QA-43
Slaughterton
Sudlersville vicinity
Private

INVENTORY FORM FOR STATE HISTORIC SITES SURVEY

"Slaughterton"

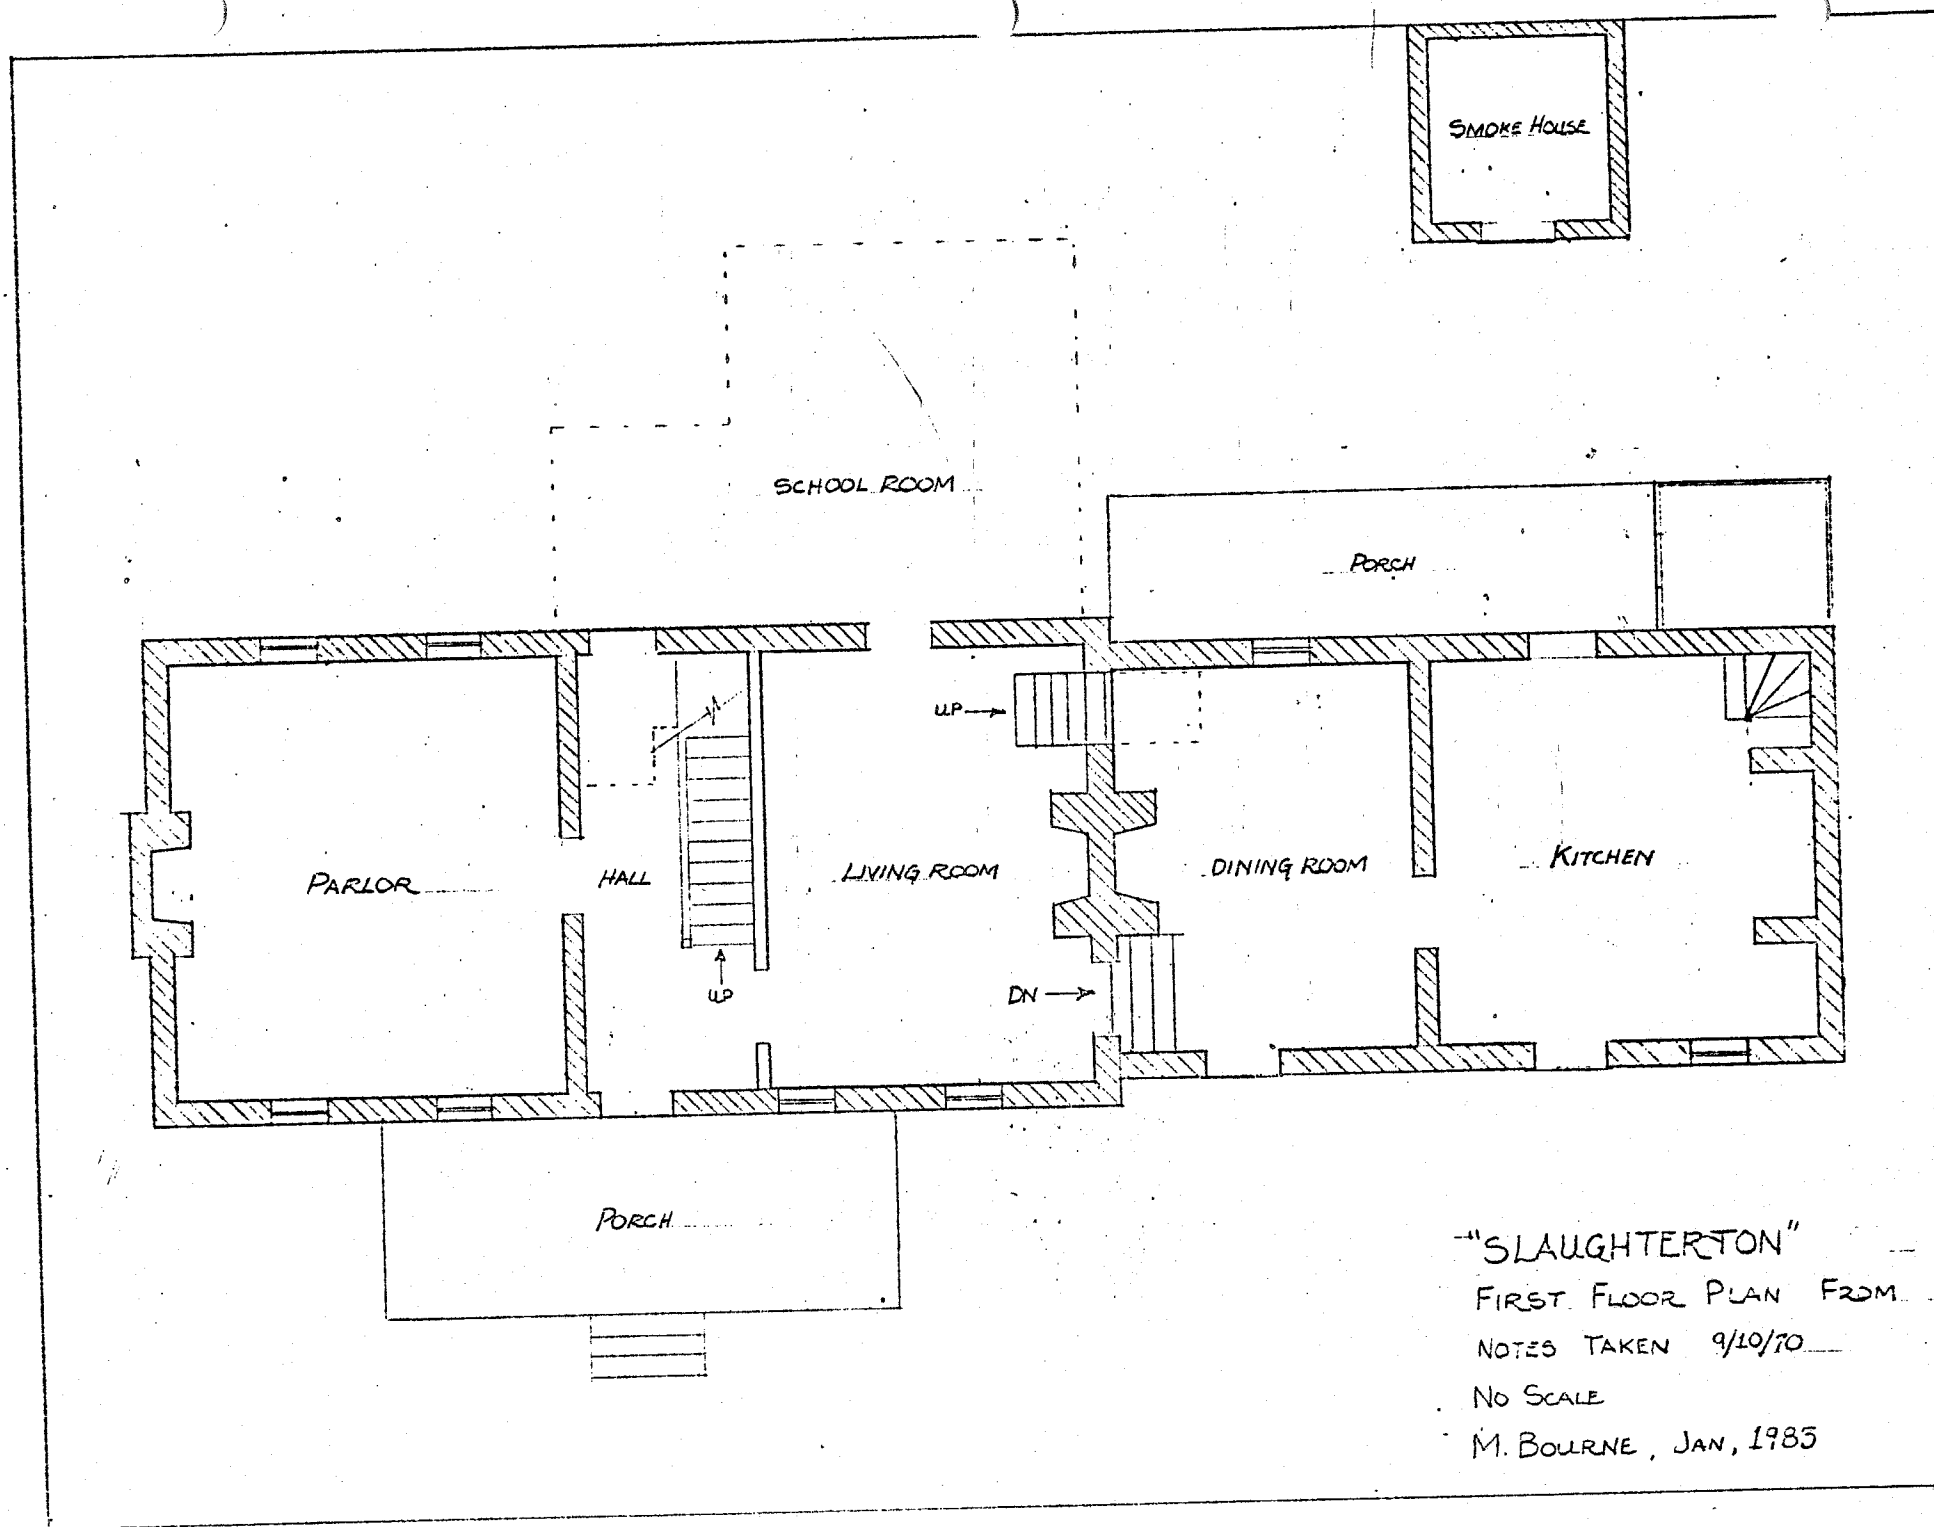
QA-43

"SLAUGHTERTON"
FIRST FLOOR PLAN FROM
NOTES TAKEN 9/10/70
NO SCALE
M. BOURNE, JAN, 1985

The floor plan consists of two rooms with central stair hall in the larger part and two rooms, several steps lower, in the kitchen wing. Beginning from the west, the parlor has a fireplace protruding into the room. It has no chair rail or cornice and the window trim has been replaced. The stair is an open string stair with two rectangular balusters per step. The living room also has a fireplace projecting into the room. On the right side is the door to the kitchen wing; on the left side are five steps up to the 2nd story of the kitchen. On the north wall is one door to the "School Room".

Both rooms in the kitchen wing, the dining room and kitchen, are paneled with sheet paneling. In the northeast corner of the kitchen is a winder stair to the room above.

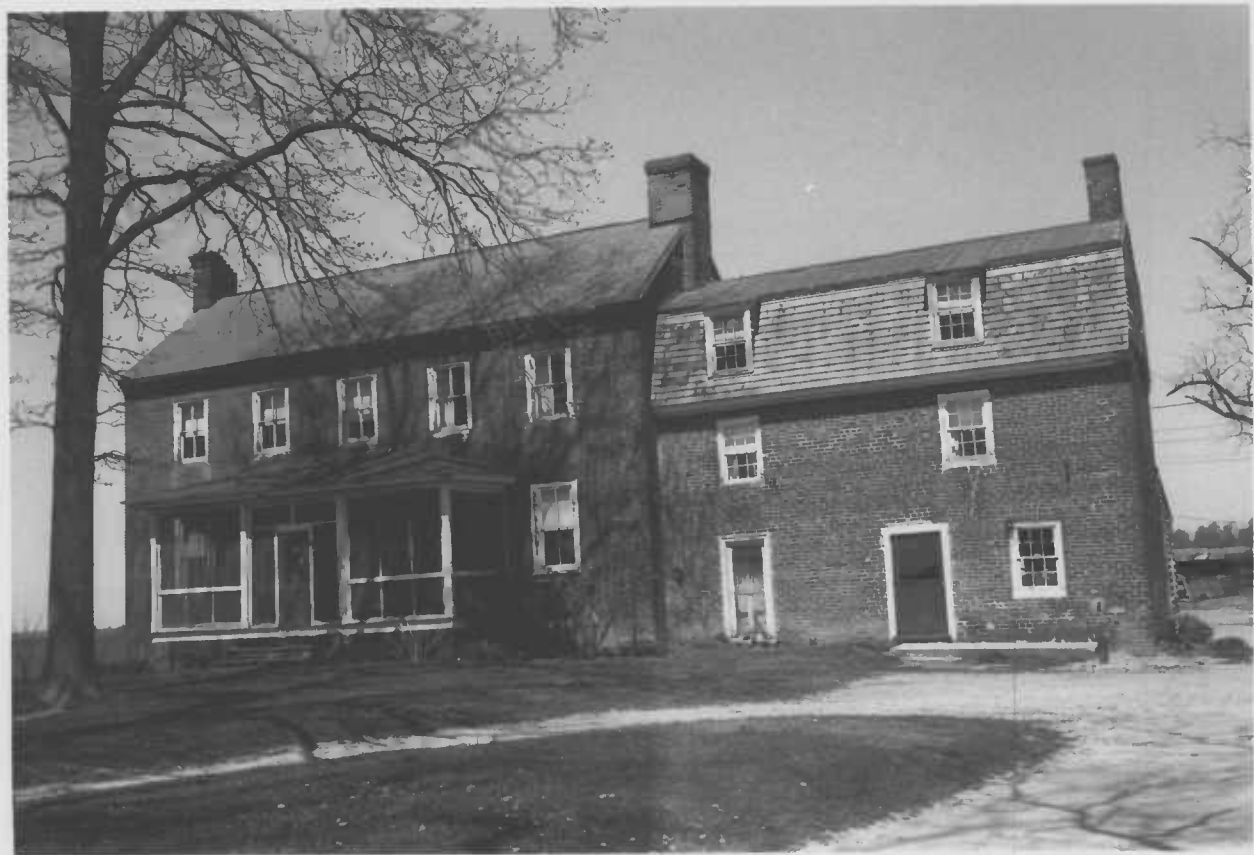
QA-43

Slaughterton
Sudlersville vicinity
James W. Valliant, April 1974
South facade

The main section of the house is five bays long, two stories and attic tall and one room deep. The south entrance occupies the central bay and retains its original six raised panel door with transom. The frames and sash of this section of the house were replaced around the turn of the century, probably when the porch was installed across three of the five bays. (Proportions of the windows suggest 9/6 sash for the first story and 6/6 sash for the second--the present ones are 2/2 on both stories). Jack arches over the openings are composed of alternating 2 headers and stretcher. There is no water table, but the cornice is composed of five courses of corbeled brick, the middle one set on an angle to create a dentil effect. The 'A' roof is covered with tin. The basement windows have five iron bars set into the masonry. The south facade of this portion of the house is the only part laid in Flemish bond; the remainder of the building, including
